NEW ROOF - 2014

Berean Baptist Church
Escanaba, MI

Roof Area = 13,260 sq.ft.

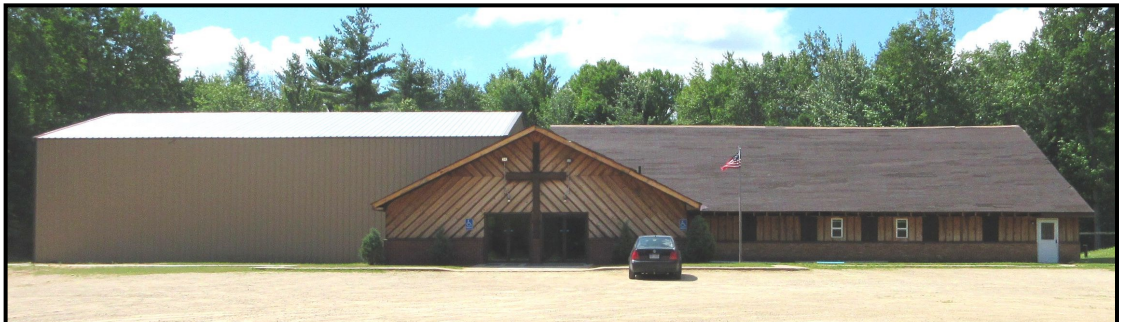
The hand built trusses in the original church had structural failure throughout the roofing system, and started its collapse during a worship service. We designed a new roof structure with engineered trusses and corrected the connecting roof lines.

Before new roof.

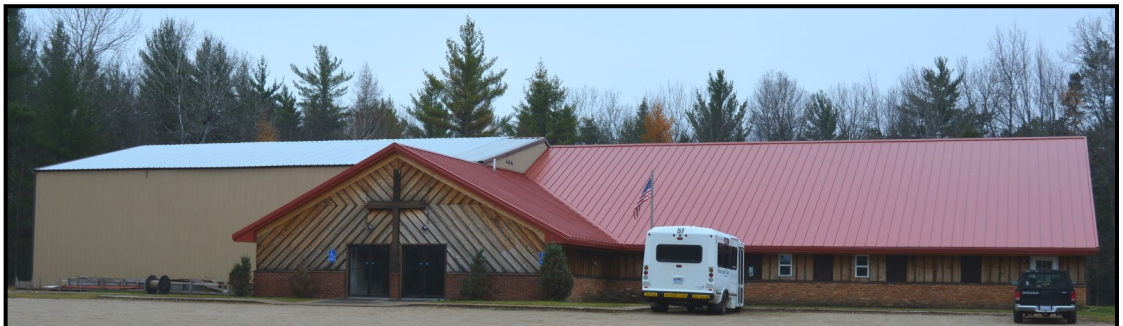
After new roof.
